The images are taken of a cam from a food processing machine. The customer is one of the biggest food producers in the UK.

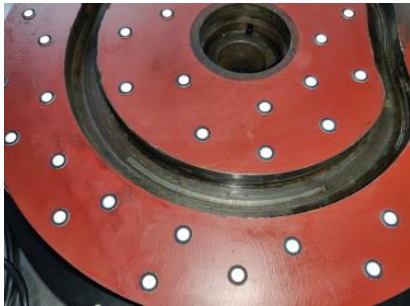
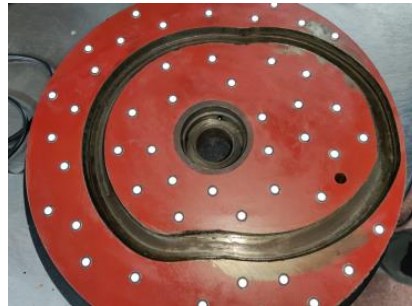
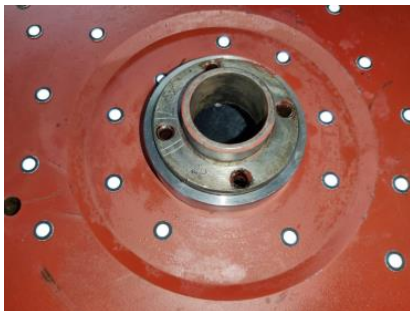
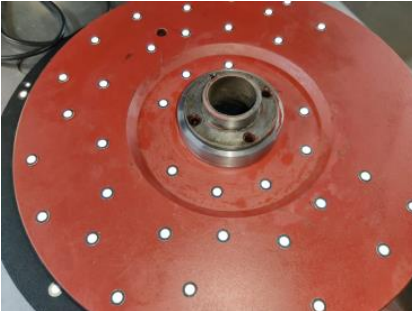
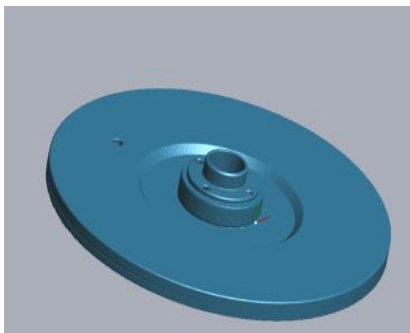
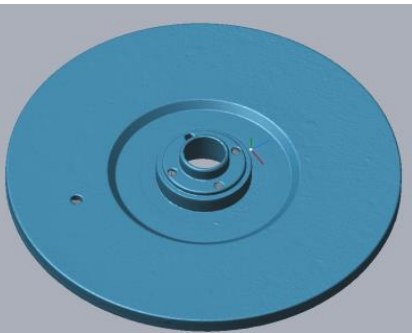
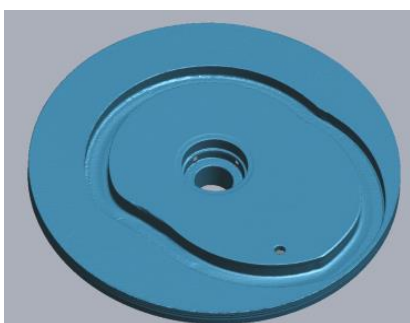
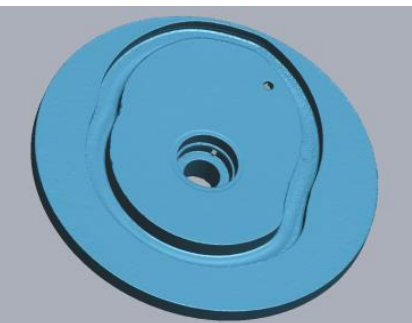
The cam has worn significantly and the machine is over 40 years old so parts are no longer available. We have scanned and reverse engineered the part in order for us to machine a replacement parts and bring the machine back into full production.
